THE INVESTIGATION OF THE FACTORS WHICH LEAD TO THE DESTRUCTION OF ORTHODOX CHURCH BUILDINGS AND THEIR PARTS

LYKHORAI V. V., *Post-graduate.*

Department of building technology, Kharkiv National University of Civil Engineering and Architecture, 40, Sumska st., Kharkiv, 61002, Ukraine, phone: +38 (057) 706-18-54, e-mail: viktoria.lykhohrai@gmail.com, ORCID ID: 0000-0001-6536-1526

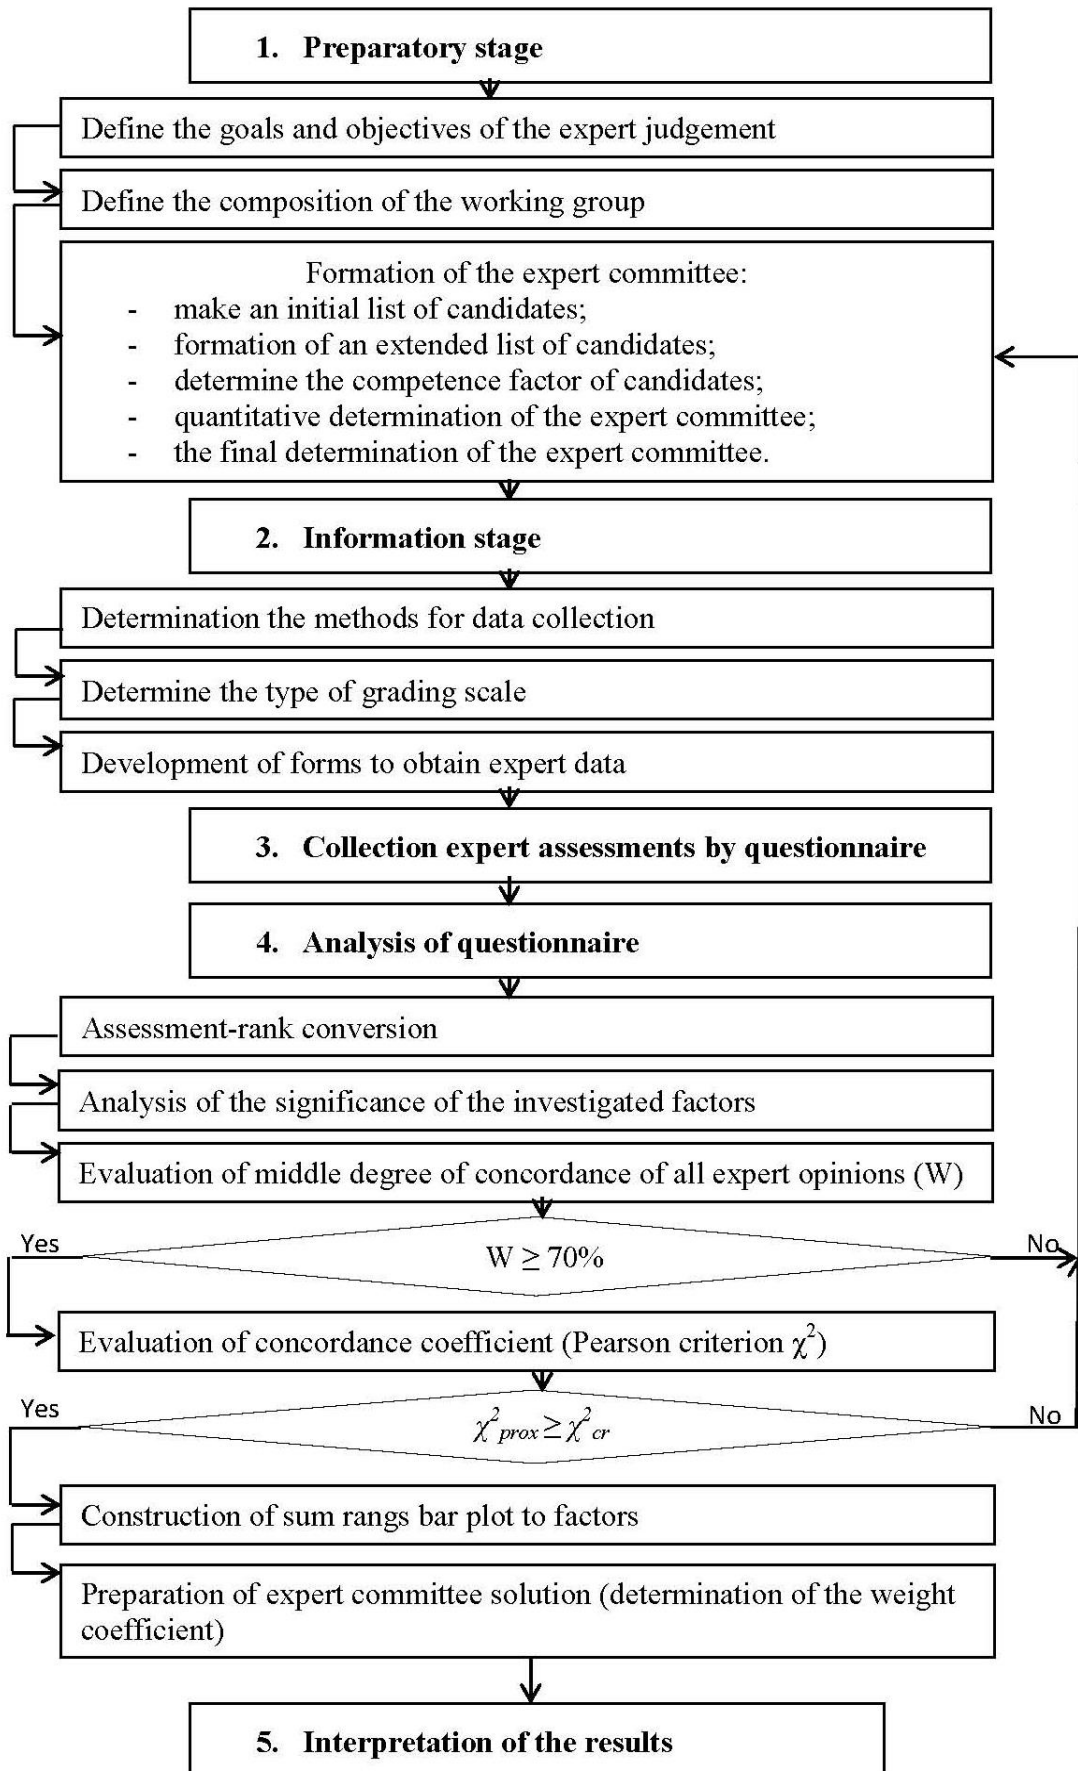
Fig. 1 - Implementation of expert evaluation algorithm

Rational organization of expert analysis of the problem of quantitative assessment and treatment results has allowed to find a solution to the research questions (Fig.1).

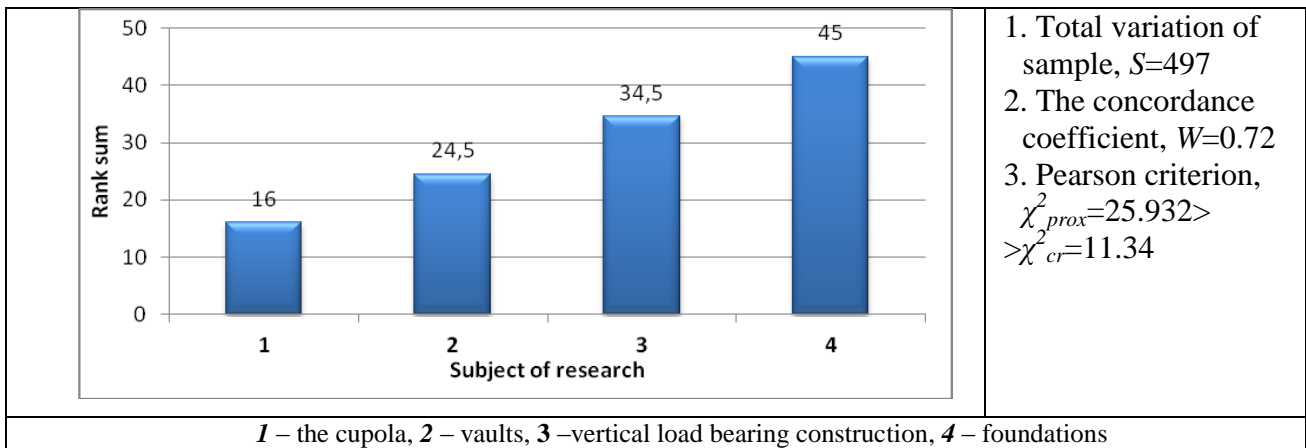
Fig. 2 – The rank sum bar plot of factors (destruction of the main structures of Orthodox churches)

As a result of research obtained diagrams of total ranks (Fig. 2, Fig. 3, Fig. 4, Fig. 5, Fig. 6), where the axis of abscissa was postponed objects of study, and the vertical axis postponed the sum of ranks. Since more powerful factors received the lowest rank (numerically) in stage ranking, then their sum

- cupolas, vaults (domes) and vertical bearing structures (walls, columns, pylons) suffered the most significant losses;
- the main destructive factors of Orthodox churches can be considered disturbance of

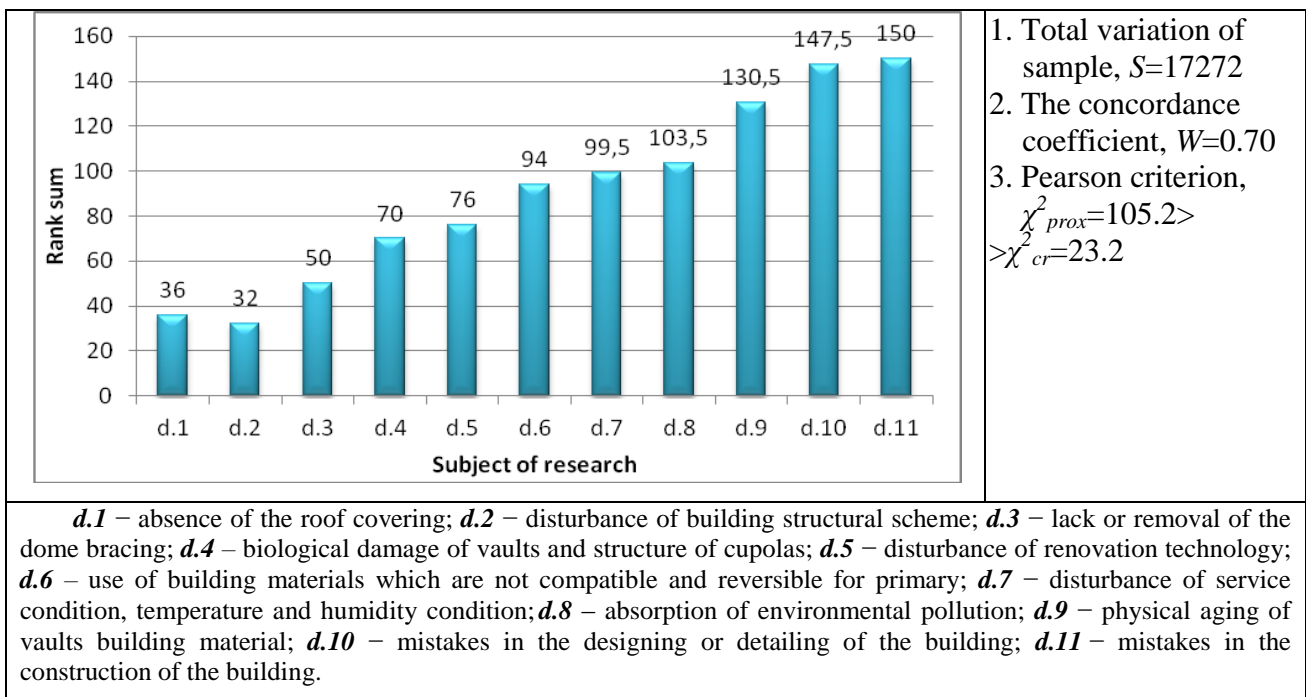
Fig. 3 – The rank sum bar plot of factors, which influence on domes technical condition of Orthodox churches

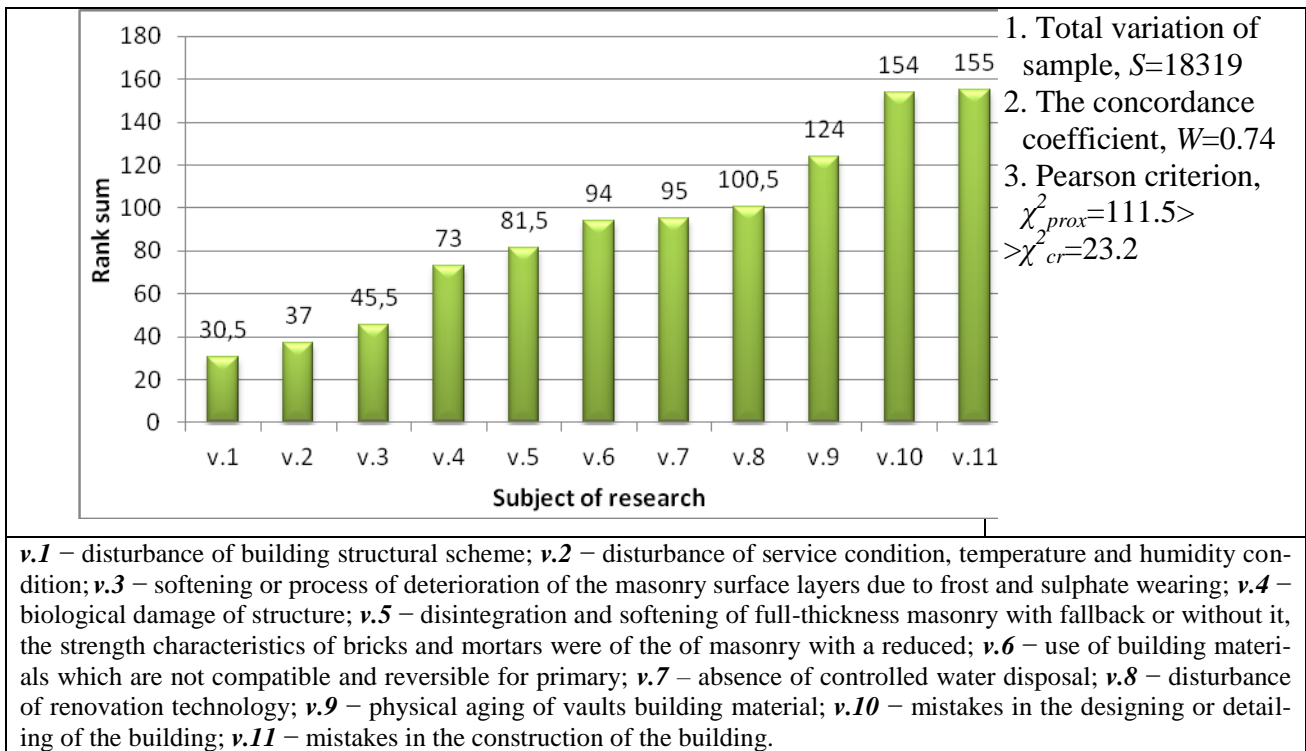
v.1 – disturbance of building structural scheme; *v.2* – disturbance of service condition, temperature and humidity condition; *v.3* – softening or process of deterioration of the masonry surface layers due to frost and sulphate wearing; *v.4* – biological damage of structure; *v.5* – disintegration and softening of full-thickness masonry with fallback or without it, the strength characteristics of bricks and mortars were of the of masonry with a reduced; *v.6* – use of building materials which are not compatible and reversible for primary; *v.7* – absence of controlled water disposal; *v.8* – disturbance of renovation technology; *v.9* – physical aging of vaults building material; *v.10* – mistakes in the designing or detailing of the building; *v.11* – mistakes in the construction of the building.

Fig. 4 – The rank sum bar plot of factors, which influence on technical condition of vertical load bearing constructions of Orthodox churches

building structural scheme of the building, disturbance of service condition, temperature and humidity condition;

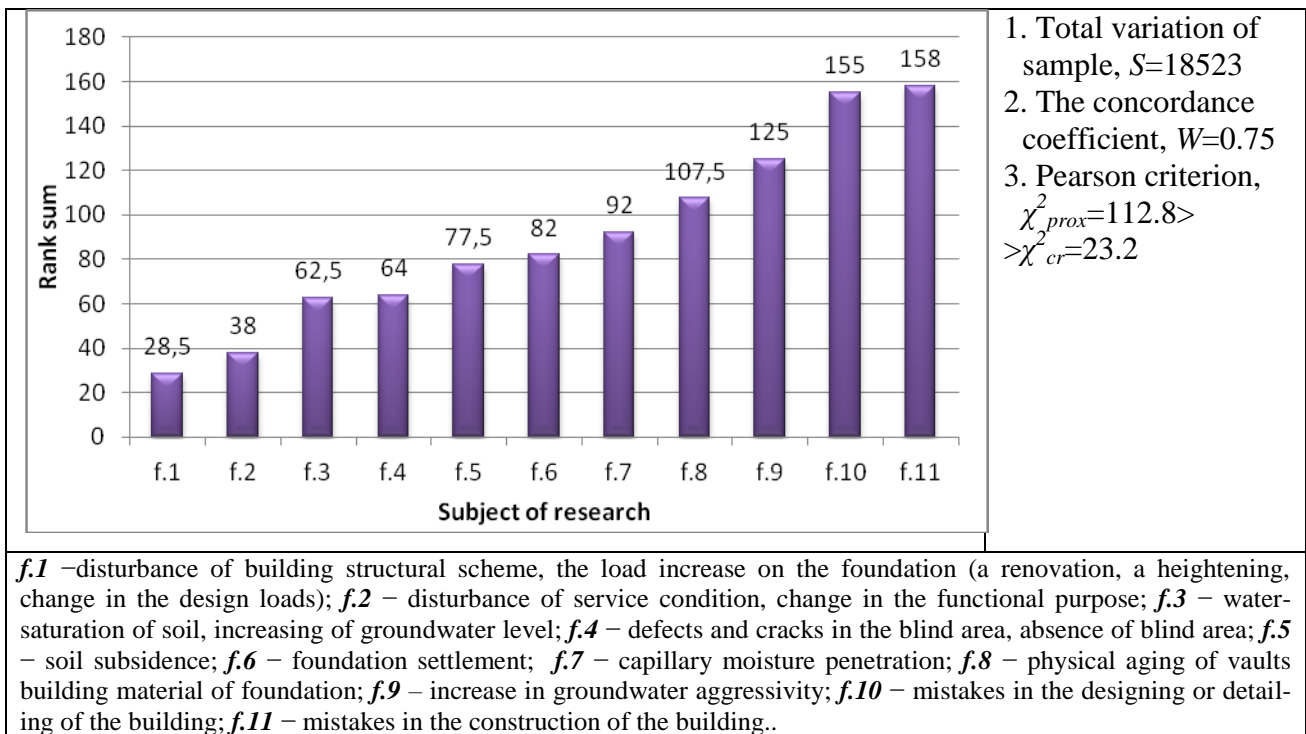
f.1 – disturbance of building structural scheme, the load increase on the foundation (a renovation, a heightening, change in the design loads); *f.2* – disturbance of service condition, change in the functional purpose; *f.3* – water-saturation of soil, increasing of groundwater level; *f.4* – defects and cracks in the blind area, absence of blind area; *f.5* – soil subsidence; *f.6* – foundation settlement; *f.7* – capillary moisture penetration; *f.8* – physical aging of vaults building material of foundation; *f.9* – increase in groundwater aggressivity; *f.10* – mistakes in the designing or detailing of the building; *f.11* – mistakes in the construction of the building..

Fig. 5 – The rank sum bar plot of factors, which influence on foundation technical condition of Orthodox churches

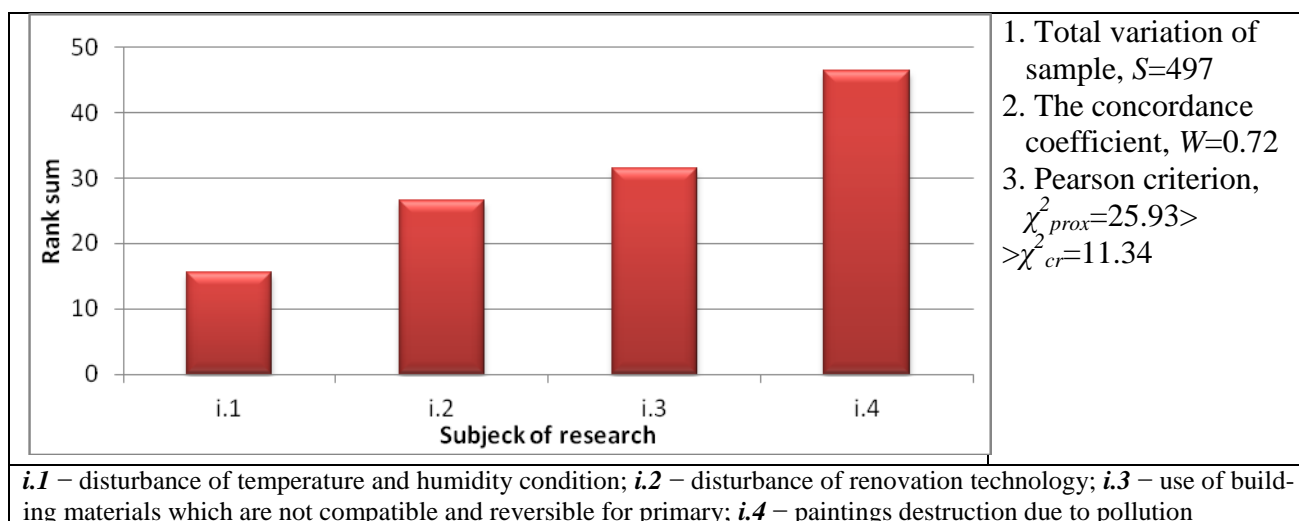
Fig. 6 – The rank sum bar plot of factors, which have the most negative impact on the interior decoration of Orthodox churches
